UNITED STATES ENVIRONMENTAL PROTECTION AGENCY
REGION IX – PACIFIC SOUTHWEST REGION
75 Hawthorne Street
San Francisco, CA 94105-3901

Region 9 Enforcement Division
75 Hawthorne Street
San Francisco, CA 94105
INSPECTION REPORT

Inspection Date:	12/10/2015		
Time:	Entry: 8:25 a.m.	Exit: 11:30 a.m.	
Media:	Water		
Regulatory Program:	CWA NPDES/Industrial Storm Water		
Company Name:	Direct Pack, Inc.		
Facility or Site Name:	PMC Direct Pack, Inc.		
Facility/Site Physical Location:	12243 Branford Street		
(city, state, zip code)	Sun Valley, CA 91352		
Geographic Coordinates:	34°15'4.54"N, 118°24'2.09"W		
Facility/Site Contact:	Luis Mendoza	Facilities Manager	
	818-896-1101		
County:	Los Angeles County		
Facility/Site Identifier:	CA WDID#: 4 19I25619		
NPDES Number:	CAS000001		
SWRCB Order Number:	2014-0057-DWQ		
SIC Code:	3081 – Unsupported Plastics Film and Sheet		
Facility/Site Personnel Participating in Inspection:			
Luis Mendoza	Facilities Manager	818-896-1101	
Mr. Patrick Ahuero	Plant Manager	Not provided	
Inspector(s):			
Kettie Holland (Lead & Report Author)	PG Environmental, LLC	US EPA Contract Inspector	303-279-1778
Signature: <i>Kettie J. Holland</i>	Date: 1/22/16

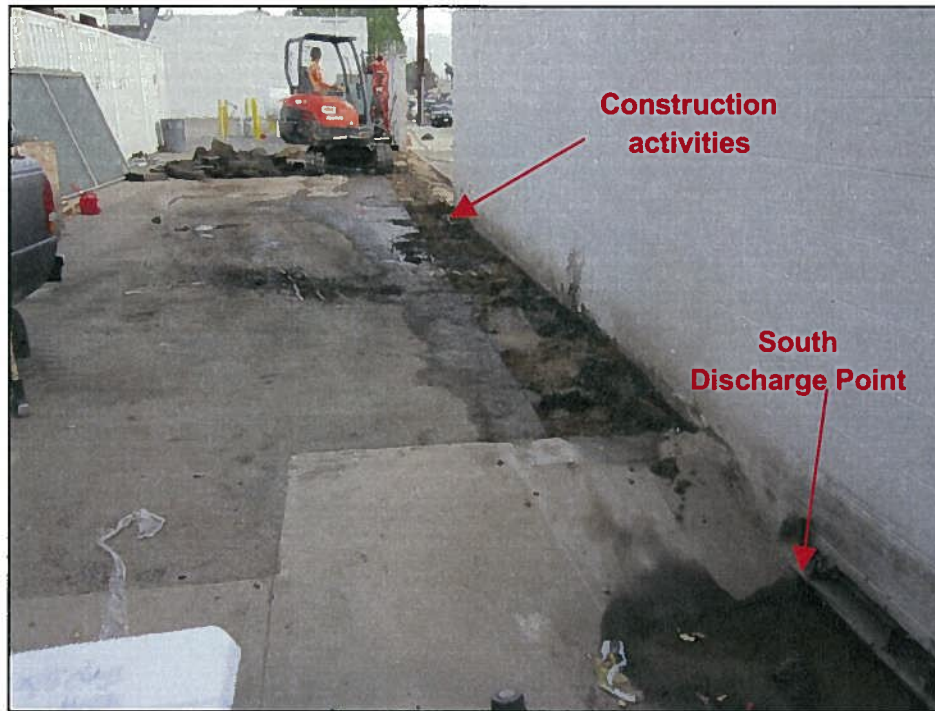
Photograph 29. View, facing northeast, of wall and sidewalk repair occurring upgradient of the South Discharge Point at the time of the inspection.
